# Effects on Diagnostic Parameters After Removing Additional Synchronous Gear Meshes

Harry J. Decker U.S. Army Research Laboratory, Glenn Research Center, Cleveland, Ohio

Prepared for the 57th Meeting of the Society for Machinery Failure Prevention Technology (MFPT) cosponsored by the Office of Naval Research (ONR), the National Aeronautics and Space Administration (NASA), the U.S. Army Research Laboratory (ARL), and the Naval Surface Warfare Center (NSWC) Virginia Beach, Virginia, April 14–18, 2003

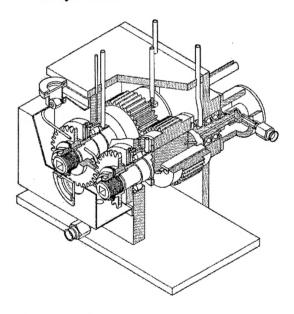
Figure 1. Spur Gear Test Facility

Facility Description: A spur gear fatigue test stand at the NASA Glenn Research Center in Cleveland, Ohio, is used to perform the testing. This facility, shown in Figure 1, is used to study of effects of gear tooth design, gear materials, and lubrication on the fatigue lives of aerospace quality gears. The test stand operates using the closed loop torque regeneration principle. The test gears are connected by shafts to a pair of helical gears that complete the loop. The torque is applied through a hydraulic loading mechanism that twists one slave gear relative to the shaft that supports it; therefore the torque is usually reported as a function of the hydraulic pressure. The drive motor only has to supply enough power to overcome the losses in the system. The test gears are lubricated with an independent oil system. The speed, torque, and input oil test temperatures can all be controlled.

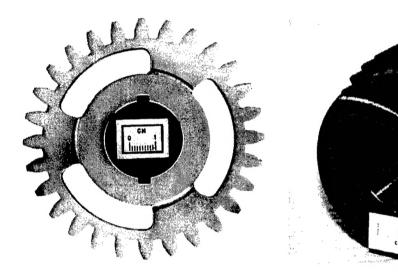
Figure 3. Sample gear for crack test

Gear descriptions: The test rig uses a pair of spur gears having 28 teeth, a pitch diameter of 88.9 mm (3.50 inch), and a face width of 6.35 mm (0.25 inch). During a surface fatigue test, the gear faces are offset by 2.8 mm (0.11 inch) to allow a higher surface stress without a corresponding increase in the bending stress. For bending fatigue tests, however, the gears are in contact across the full face width. The tests are also run at a higher torque than normal to assist in the formation of a crack front. A photograph of a test gear is shown in Figure 3.

The slave gears (Figure 4) have 35 teeth, a pitch diameter of 88.9 mm (3.50 inch), and a face width of 38.1 mm (1.5 inch). They are run at full face width. As such, they are lightly loaded and under certain conditions generate more vibration than the test gears.

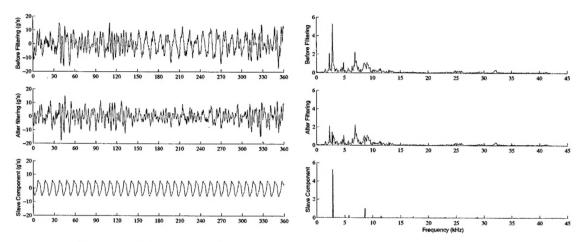
Figure 5. Effects of slave mesh filtering

Figure 5 illustrates the effect that other synchronous gear meshes can have on a vibration signal. In the uppermost plot, the synchronously averaged vibration is plotted as a function of angular position during one revolution. The middle plot shows the result of removing the slave gear mesh and its harmonics (not including those that are coincident with the test gear harmonics). Finally, the lower plot shows the contribution due to the slave gear mesh.
